**METALLURGICAL EVALUATION AND
FRACTURE ANALYSIS OF A
PNEUMATICALLY-BURST SEAMLESS
STEEL COMPRESSED GAS
CYLINDER**

Bruce W. Christ and John H. Smith

Failure Analysis Report

April, 1977

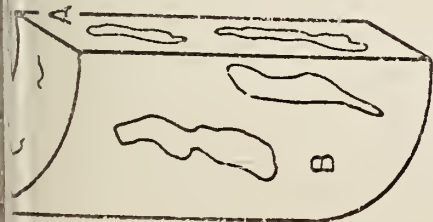
The average tensile and yield strengths in Table VII compare favorably with the average tensile and yield strengths in Table III. However, reduction in area and elongation show decreases of about 30 and 40%, respectively. Hence, there seems to be no orientation dependence for strength, but a substantial dependence for ductility. This reduction in ductility is attributable in part to the inclusions elongated in the longitudinal direction, Figure 15.

A - Longitudinal Section -
Circumferential Direction

B - Longitudinal Section -
Radial Direction
